Full Condition Assessment Report

Customer: Northern Ireland Water				Reason for assessment: First full assessment, and Condition assessment after control change at Drummer Road			
FAO:				Analyst: Rob Pietruszkiewicz & Geoff Walker			
Date: 22 March 2010				Last report: 12 Feb 2010 (Initial interim report on Drummer Road Inverter issues)			
MCM#	Machine	Condition	Trend	Diagnosis	Action	Urgency	Details
1	Drummer Rd, pump 6	●	▶	Slight loose foundation. Previous High-current problems now cured, by clamping inverter frequency to correct limits	None required – except to confirm reasons for it not running (assumed simply to be control system not calling for it)	Low	A1
2	Hunters Crescent, transfer pump 3	●	▶	Generally good condition. Some indications of possible loose foundation. Not a deteriorating trend. Power reduced on 18 March	Confirm impeller design – has it got 4 blades? Identify reason for power decreasing on 18 March.	Low	A2

A1: Detailed assessment for Drummer Rd Pump 6	
Customer: Northern Ireland Water	Reason: Condition assessment after control change
FAO:	Analyst: Rob Pietruszkiewicz
Date: 22 March 2010	MCM#: 1 (Dromer Rd)

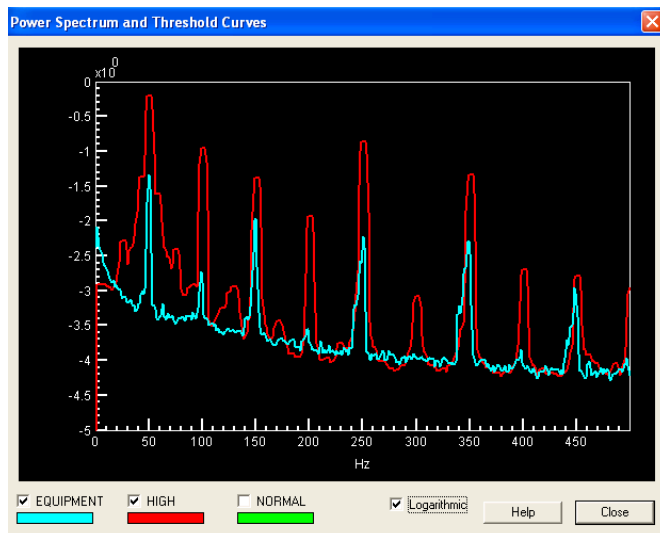
The overall condition of this pump looks good, with no obvious problems visible, apart from signs of a soft foundation. This appears to be confirmed by the reports of very significant vibration when the speed was set to anything outside a narrow range. The overall picture can be deduced from the diagram below, which shows in blue the signal coming from the motor analysis, and in red the acceptable threshold level. This shows that the blue line is below the red in virtually all areas except the very low frequency end, which corresponds to the foundation problem.

Figure 1: Power Spectral Density (PSD) curve showing soft foundation.

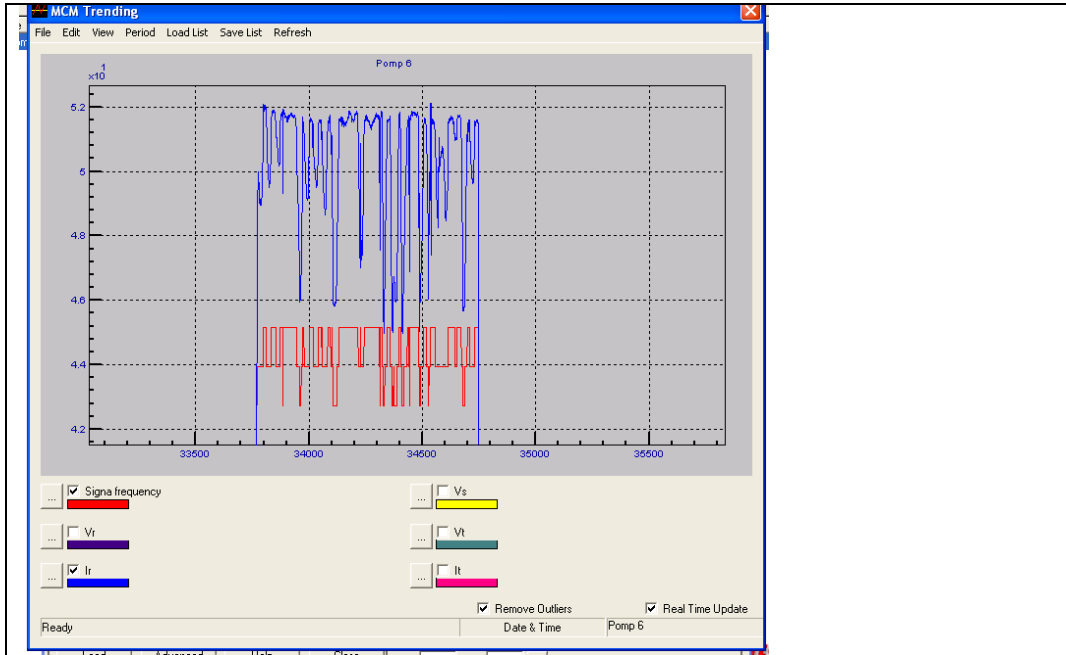
This problem has now clearly been resolved – the input frequency can now clearly be seen to be limited to a maximum of 45.1 Hz. The trace below shows that the inverter gives a stepped output, with a frequency of either 42.7Hz, 43.95Hz or 45.15Hz with the resulting motor current reaching a maximum of around 520A

Figure 2: Motor Current and Frequency showing both within acceptable limits

Now that this issue has been resolved, we see no electrical or mechanical faults in the motor or pump (other than the pre-existing foundation fault previously reported – which has not deteriorated further).

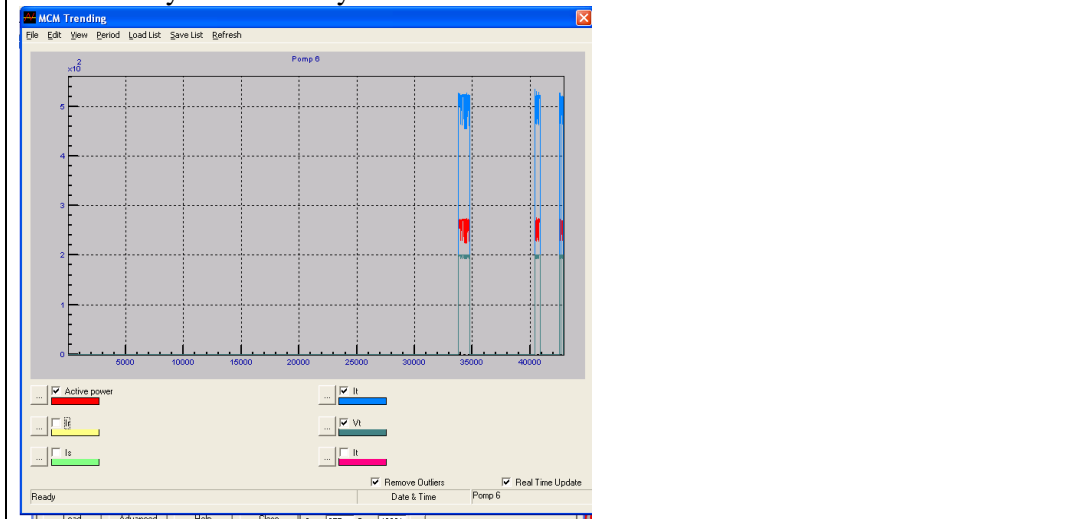
However we note that the pump is not always running. We see no data to suggest that it should be tripping out for any reason, and assume that it is simply being switched on and off by the control system.

Figure 3 Power, Current and voltage trends – showing very intermittent operation

However, trend line for Power, Voltage and Current shows that motor is only running intermittently. We have no way of telling why this is, but there are no identifiable reasons that we can see that would lead to the pump tripping out or not running correctly.

None required – except to confirm that the reason for the pump not running more frequently is simply the control system not calling for it.

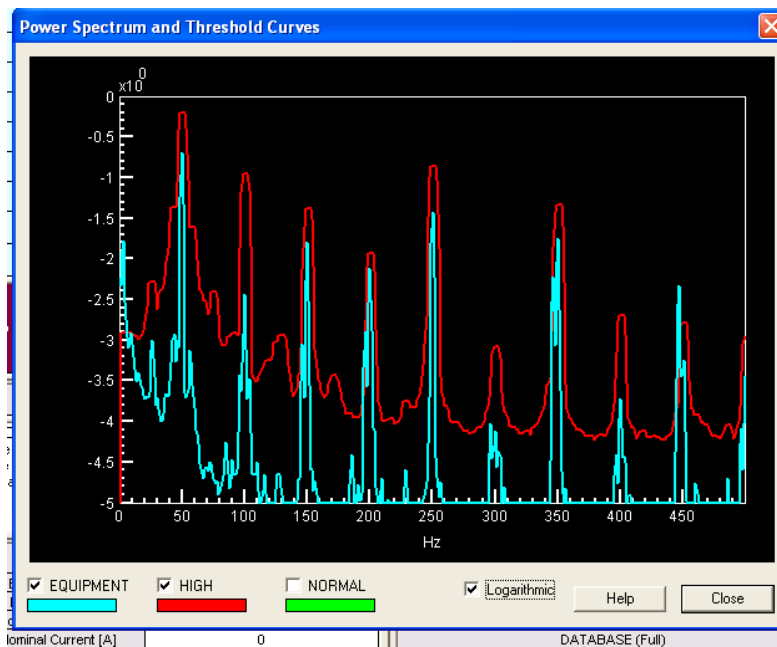
The overall condition of this pump looks good, with little obvious problem visible. The traces we can see would appear to indicate a vane pass frequency consistent with a 4 bladed impeller. The overall picture can be deduced from the diagram below, which shows in blue the signal coming from the motor analysis, and in red the acceptable threshold level. This shows that the blue line is below the red in virtually all areas except the very low frequency end, which could correspond to a foundation problem, or possibly some misalignment, but the specific shape and location of the peaks on it are more consistent with a vane pass of a 4 bladed impeller.

Figure 4: Power Spectral Density (PSD) curve.

No urgent action required. Next time someone is on site, it would be helpful to check whether there is any sign of either loose foundations (which would indicate itself as a loud rattling type of noise) or of misalignment (which at the levels shown would probably only be detectable with laser alignment type of equipment). We expect that neither of these problems will be significant, and their absence will confirm that the signals we are looking at probably correspond to a 4 blade impeller. It would also be useful to have someone confirm the details of the impeller – number of vanes and geometry – to allow future diagnoses to be much more specific.

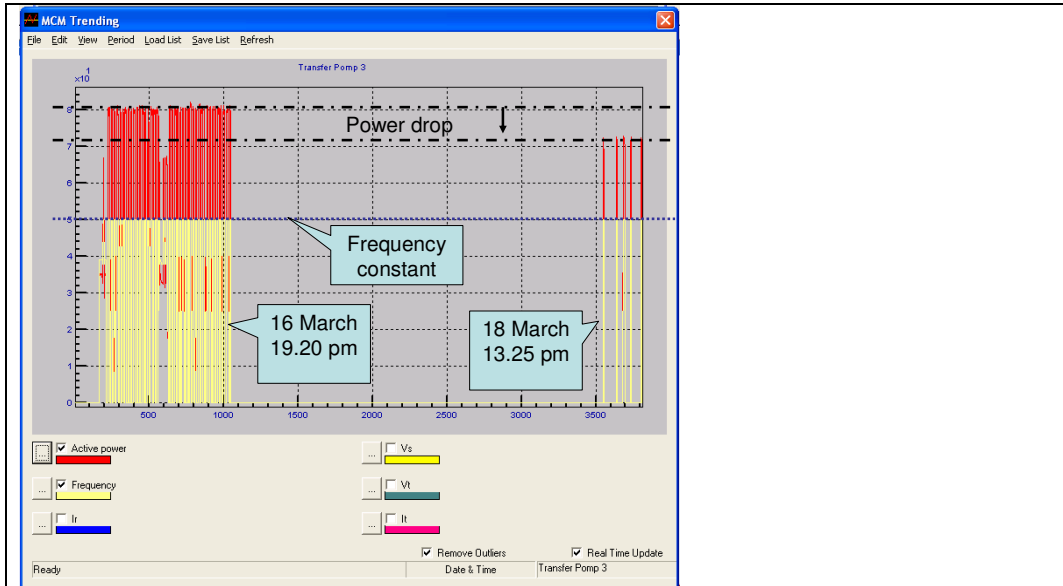
Looking at overall pump usage and performance, the recent traces show that something has changed on the pump between 16th March and 18th March, in that the pump was out of action for 36 hours, and when put back into action, the power consumed by the pump was reduced by around 10-15%. The power factor is pretty constant before and after, the power reduction is simply associated with the motor drawing less current. Although this is a variable speed motor, it is being operated at constant 50Hz almost all the time, and there is no change in supply frequency which would have led to a change in speed of the pump corresponding to the time of this reduction in power,. So we can only assume that there has been something else leading to a change in load in the pump – perhaps adjustment of a valve somewhere in the system, changing the flow through the pump.

Figure 5: plot of power consumption and frequency, showing reduction in load on 17/18 March whilst frequency, and therefore pump speed, remains constant

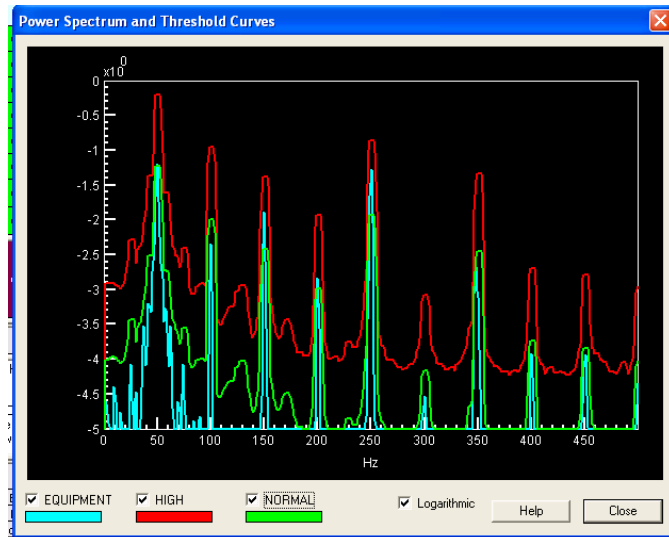
The overall condition of this pump looks good. The blue line in the graph below is at all times well below the upper threshold indicated by the red line, and is below the green line at almost all points, ie it is in a better than a normal condition

Figure 6: PSD curve for Duncrue Road – virtually all below Green line

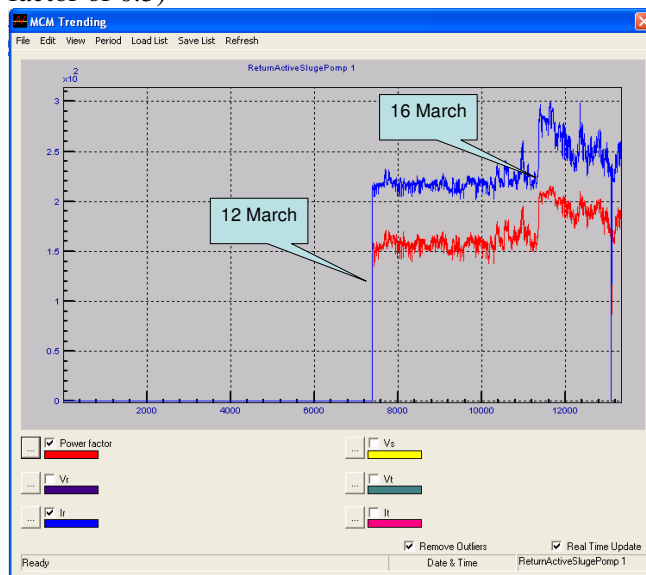
The one area that is abnormal is the power factor – which is very low, at around 0.5 – 0.6. This is shown in the graph below as the red line, together with the current, which is shown as the blue line. (Note: to make the lines more easily comparable, the power factor line has been scaled by a factor of 300; so 1.5×10^2 corresponds to a power factor of 0.5)

Figure 7: Power Factor and Current consumption – low and varying

The fact that the power factor scales directly with current indicates that this is purely the result of a low and changing load on the pump, or conversely that the motor is oversized for the duty that it is being asked to perform at the time we are observing.

Low power factor is not necessarily a problem, but it does represent a waste of money, in that lower power factor implies that a significant amount of current is being drawn out of phase with voltage, delivering no useful result, but still incurring a cost for supply of electricity.

Without knowing more detail about the duty of the pump, and with only a short record so far we cannot be sure that a smaller motor would be able to handle all of the duty requirements of this pump, but it should be watched with this in mind as a possibility. Alternatively, greater efficiency can be obtained by fitting an inverter drive unit to the existing motor / pump system.

None required – except to review system loading and consider saving energy either by fitting smaller motor or using variable speed drive system.

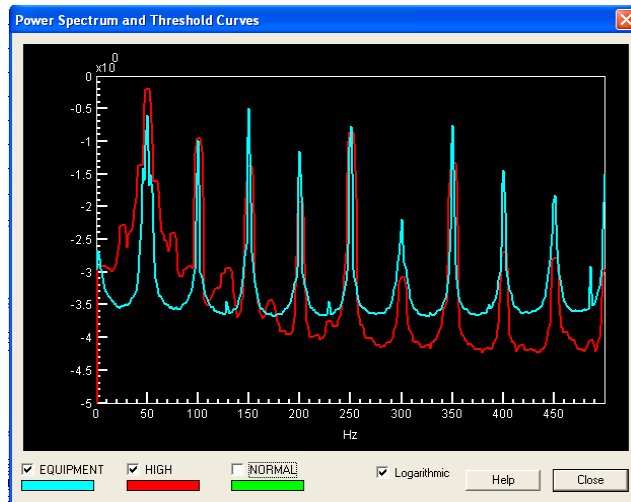
The overall condition of this pump appears to show a lot of rubbing contact and looseness, so the blue line in the graph below, which corresponds to the signal coming from the equipment, has a very high “carpet” level, ie it doesn’t go very low in between the peaks. This normally corresponds to rubs and general noise and looseness. It is noticeably higher than the red line, which is a normal high limit.

A more detailed analysis of the shape of the curve indicates an energy signal corresponding to a feature occurring twice per revolution, so given this is a screw pump, it might indicate that the screw is a double rather than single helix. It might also indicate misalignment. With no detailed information on this specific pump we cannot be sure which of these phenomena we are seeing, and it may of course be both!

Alternatively, this frequency pattern can indicate a developing problem in the stator windings of the motor. Without a little bit of inside information it is not possible to be certain of this, but our expectation is that it is more likely to be mechanical problems rather than the motor.

Figure 8 – PSD Curve showing high carpet noise level and high peak levels

This pump is not in perfect condition. It should be kept under watch. However, at the moment, there are no indications of significantly deteriorating trends, so we do not see any signs that would lead you to expect imminent failure.

The MCM outputs should continue to be monitored, and any deterioration logged.

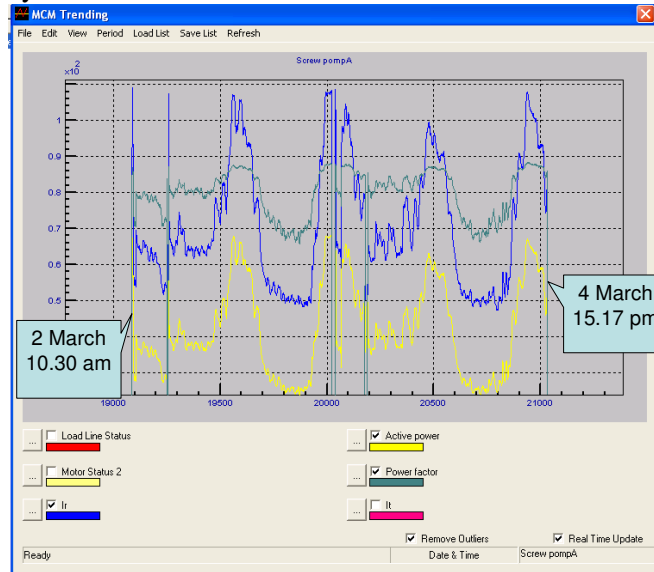
Figure 9: Current, Power and Power Factor vary significantly from hour to hour

The difference in load varies by a factor of more than 2: 1, with the current ranging from around 50A to around 110A, and the associated power consumption ranging from 25 to nearly 70 kW. The power factor follows a similar pattern, as would be expected, with lower currents corresponding to a lower power factor. However, trend line for Power, Voltage and Current shows that motor is only running intermittently. We have no way of telling why this is, but there are no identifiable reasons that we can see that would lead to the pump tripping out or not running correctly.

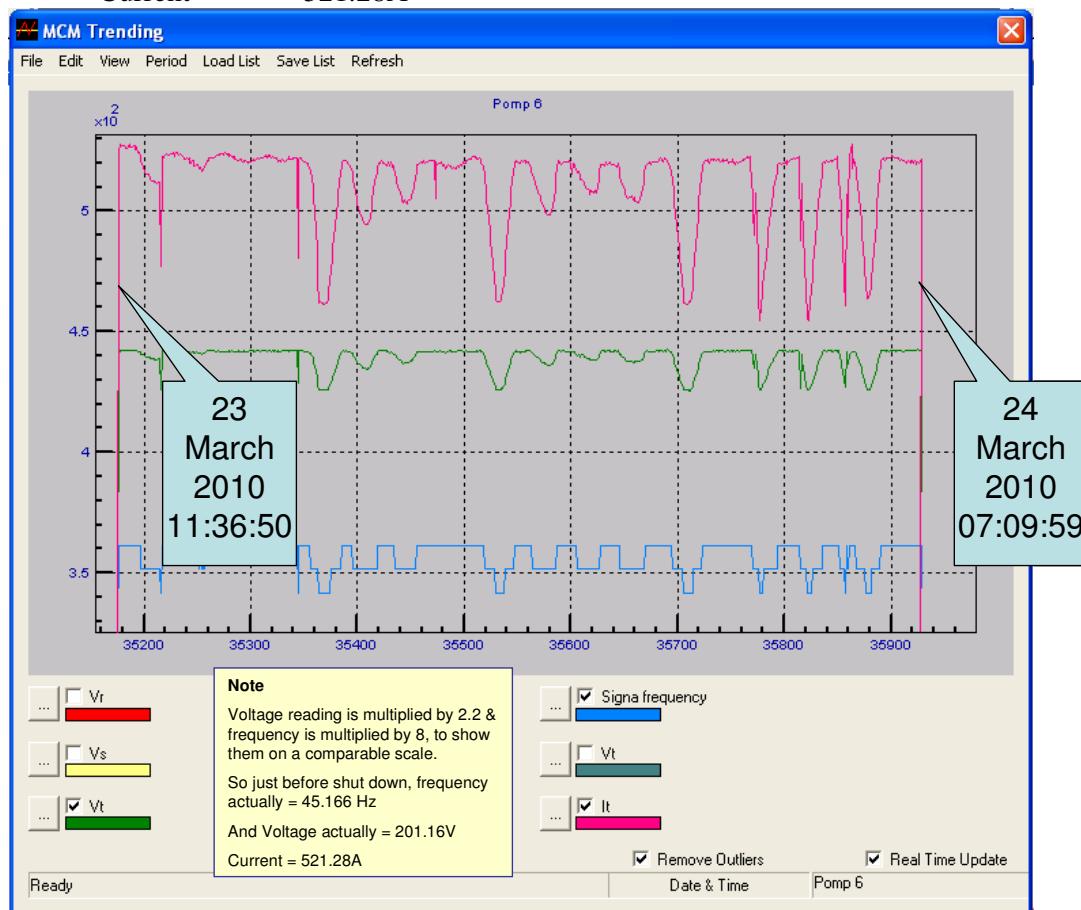
It has been reported that pump 6 at Drummer Road continues to trip out, with the Inverter Unit reported to indicate High Current. We have examined this, and cannot see any evidence to support this. Below is a plot based on data taken on 26 March 2010, showing the readings on Wed 24th March, when the unit shut down.

- Frequency = 45.166 Hz
- Voltage = 201.16V
- Current = 521.28A

Figure 10: details of Voltage, Currency and Frequency of Drummer Road Pump 6 just before shut down on Wed 24 March.

So from this picture, we have no reason to suspect the inverter is giving high voltage, or high current, or high frequency. We advise that the alarm messages from the inverter be double checked, and the manufacturer be consulted to try to understand how the error message reported could be consistent with the voltages and currents actually being drawn.
