Artesis MCM Case Studies

Prof. Dr. Ahmet Duyar
2009

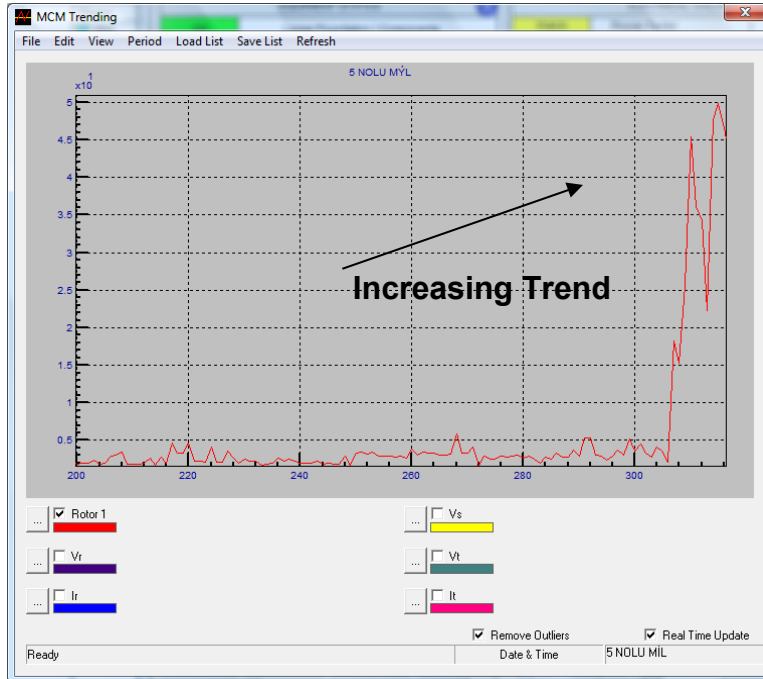
Rotor failure parameter trending for 5th Mill motor

Goodyear Tire and Rubber Company is one of the biggest tire manufacturer in the world. MCM units are used to monitor some of their equipment in Sakarya plant. One of them is 5th Mill Motor. MCM detected some existing failures, transmission and unbalance, after LEARN period. Several months later, MCM gave “Rotor” fault alarm to the user, and TPM chief engineer decided to check the failure with vibration measurement also. Siemens TPM team did some vibration measurement on the motor and they reported that 5th mill motor has one or more broken bars on the rotor. Hence, early predictions given by MCM were also verified using vibration tests.

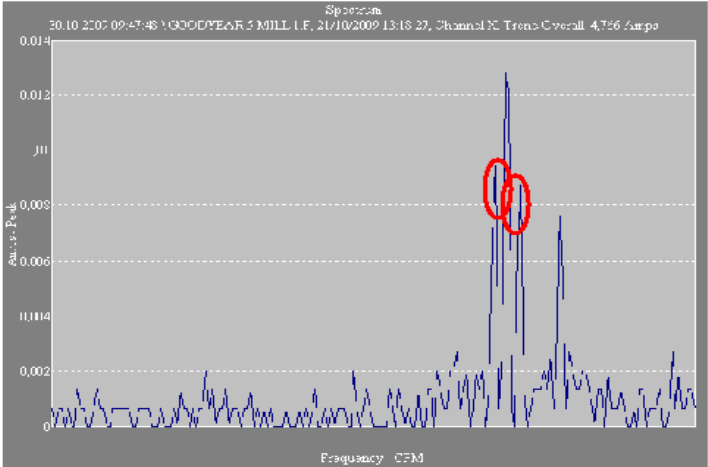
Subject : 54 CAL. 1 - 5 Mill Motor

At 21.10.2009 motor dB measurements. You can see peaks at 3.5 pole pass frequency on spectrum. These peaks equal 44.9 dB . this means moderate. You can see condition assessment table below.

54 - 60 dB = Excellent
48 - 54 dB = Good
42 - 48 dB = Moderate
36 - 42 dB = Rotor bar crack developing or High resistance joints
30 - 36 dB = Multi cracked broken bar sor End – Rings Indicated
< 30 dB = Multi cracked broken bar sor End – Rings very likely Severe problems throughout

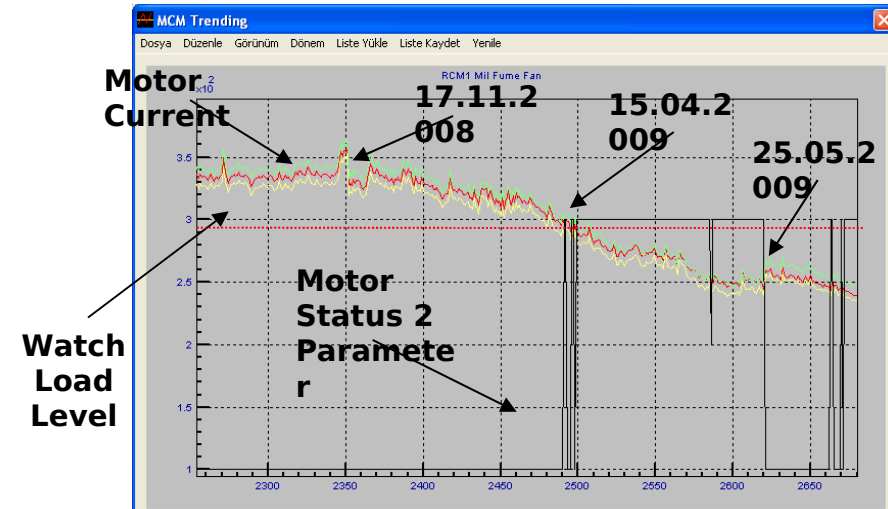
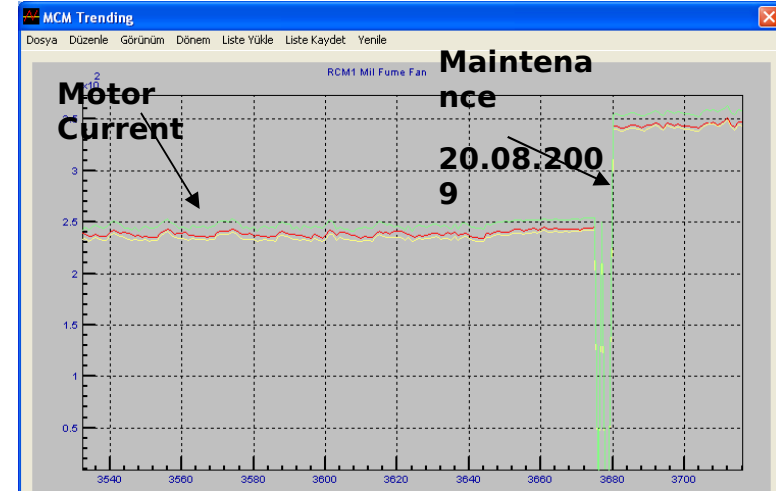
Borcelik is one of the biggest steel – iron factory in Bursa/Turkey and uses for monitoring their equipment. One of them is Reversing *Cold* Rolling Mill fume fan. This fan has a filter and it discharges dusty air out of the factory. MCM started to warn user by giving “Watch Load” alarm after 15.04.2009. When the current trending examined, it could be seen that motor current is going down since 17.11.2009. This means filter blockage started that date, but it exceeded MCM alarm level on 15.04.2009. Maintenance team of Borcelik tried to clean the filter with pressured air on 25.05.2009, but it did not make the filter completely clean. So MCM started giving “Watch Load” error just after 1 month after maintenance operation. They needed to change the filter on 20.08.2009 and after this MCM stopped giving error and motor current increased to its nominal value.

If the process load has not been altered deliberately, check for leakage, valve & vane adjustment, pressure gauge faults, manometer, dirty filters (fans, compressors). If the process is altered deliberately, MCM/PCM should be updated.

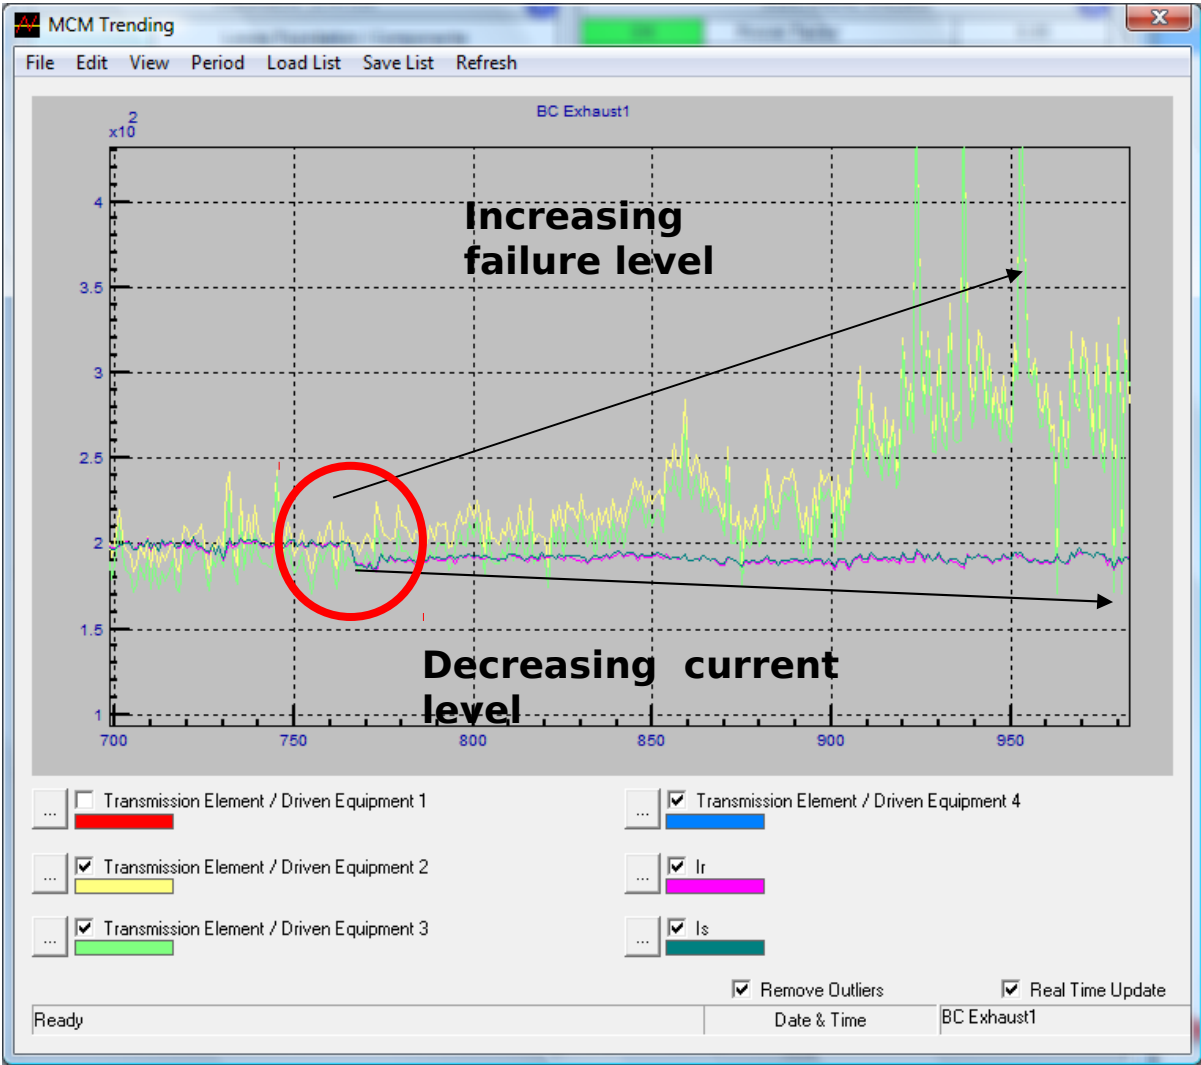
Karsan Automotive Belt Looseness

Karsan, a leading in Turkish automotive industry. They manufacture some automotive models for Hyundai, Renault and Peugeot. MCM units are used in their paint shop. One of the equipment MCM monitors is an exhaust fan that discharges air with paint particles. Power is transmitted by a belt to the fan. MCM indicated a transmission fault. The trending data indicates to a loose belt. This means motor slips due to belt looseness and can not transmit all the power to the fan as also indicated by decreases in the three phase currents. The performance degradation due to loose belt is verified and corrected by Karsan maintenance team.

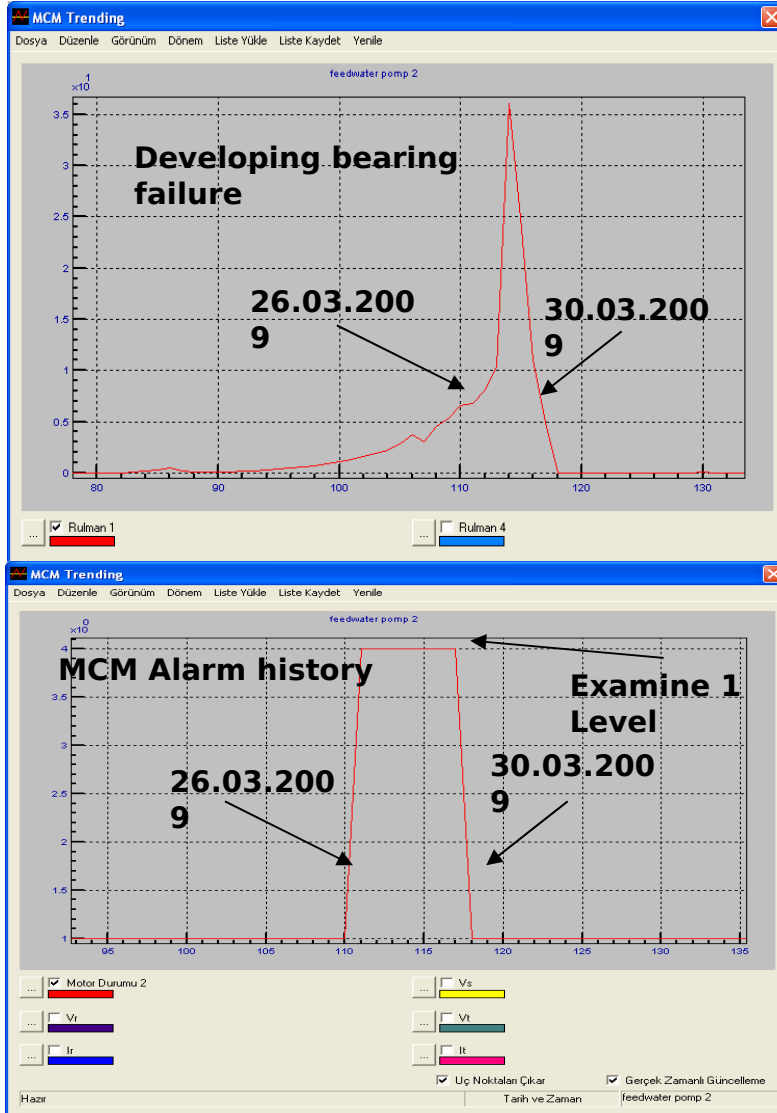
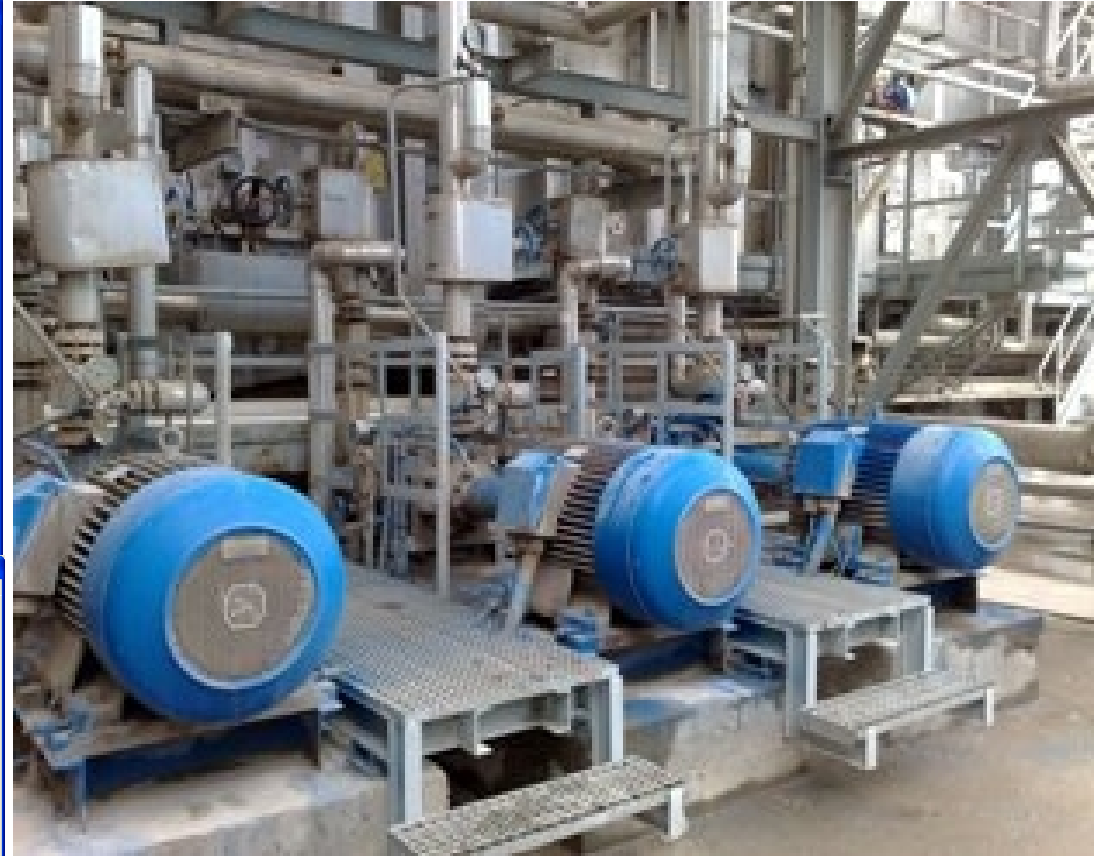
Nuh Energy Bearing Failure

Nuh energy has 159 MW installed energy generation capacity. Nuh Energy maintenance team has been monitoring one of the feed water pump of the generator by MCM. One month after the installation, MCM indicated a developing “Bearing” fault. Maintenance team verified the bearing fault and replaced the bearing of the motor. After the maintenance action MCM stopped giving alarm verifying the effectiveness of the maintenance action.
