## ***Cases of Success***

### **PA-01 & PA-02**

***Documents referred to actual applications which had successful identification of failure processes using predictive analyzers PA-01 and PA-02.***

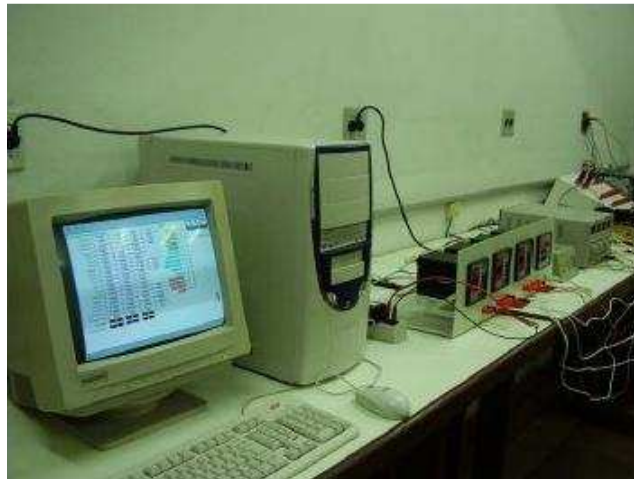
**Application: Lab Tests – Simulation of real situations**

**A joint effort was developed for two months in DEPEL facilities. During the tests, the PA-01 underwent the following situations:**

- Rotor misalignment**
- Power grid imbalance**
- Load variation**
- Insulation loss**

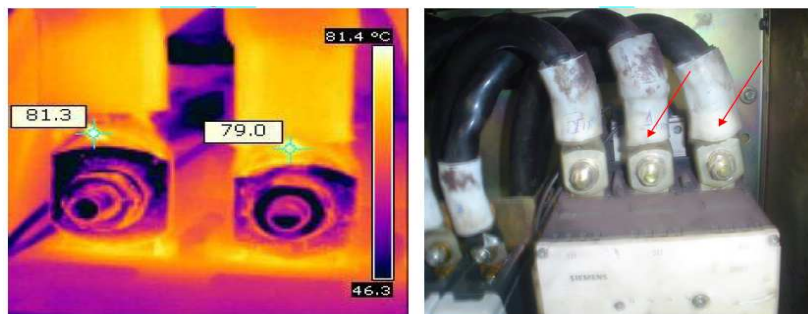
**The pictures below show a thermographic analysis performed by the client that confirmed overheating in system power supply circuit components, such as breakers and contactors. The PA-01 indicated this failure.**

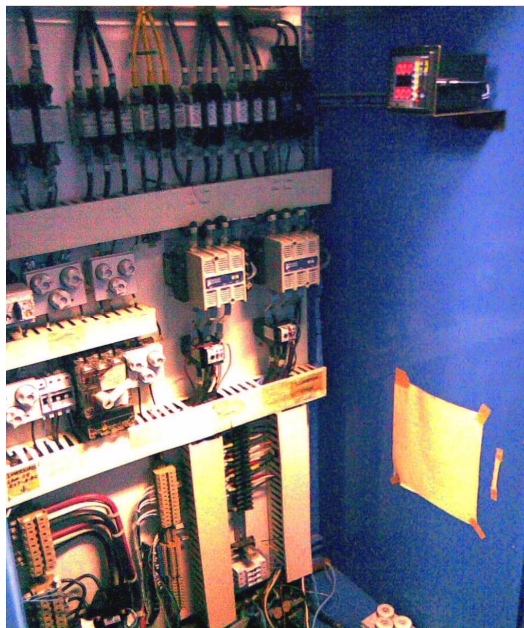
**Application: Cylinder Cooling Pump**

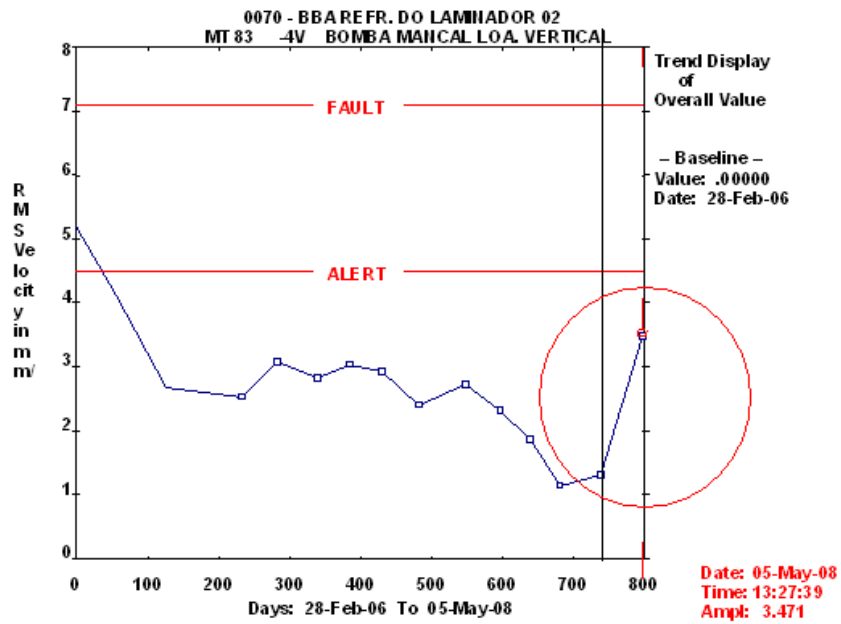
**Then, the client issued a vibration analysis report. The picture below shows highlighted by a circle the period in which PA-01 monitored the application. Note that the monitored system condition worsened almost reaching the ALERT level.**

The line represents the period the PA-01 is monitoring the application.

**“On May 5<sup>th</sup>, the equipment was measured in normal measuring program”.  
“The equipment shows initial clearance and slight misalignment”.**

**As we see, the vibration analysis document confirmed the initial failure.**

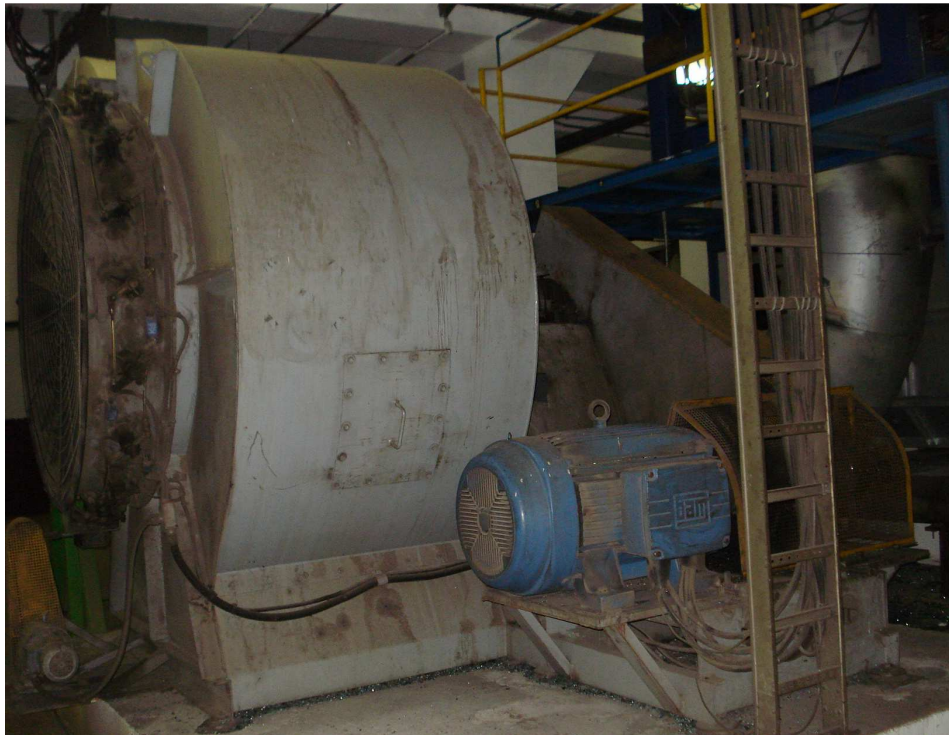
**Application: Glass cooling blower**

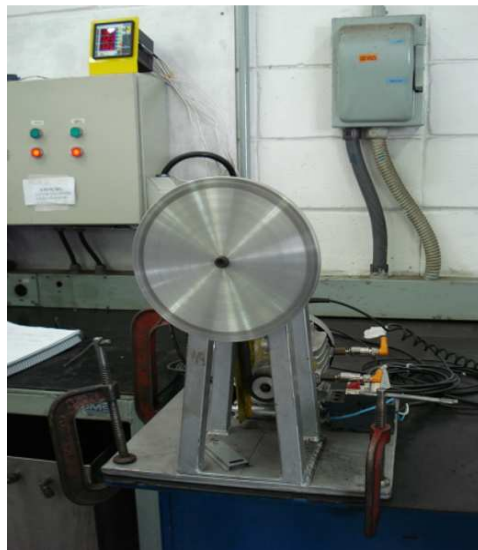
**Application: Workbench test – Motor driving a disk**

**Results: The client was interested in perform a workbench test with the PA-01. KRON personnel visited the company in order to provide guidance on test procedures. The test consisted of gradually placing weight on the disk driven by the motor.**

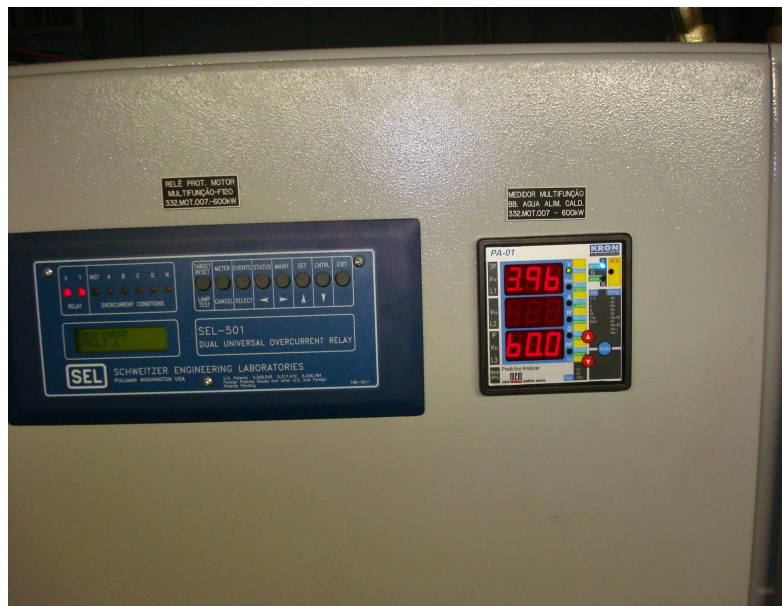
**Application: Water pump for boiler supply (autonomous power generation)**
