Artesis MCM Case Studies

Prof. Dr. Ahmet Duyar
2009

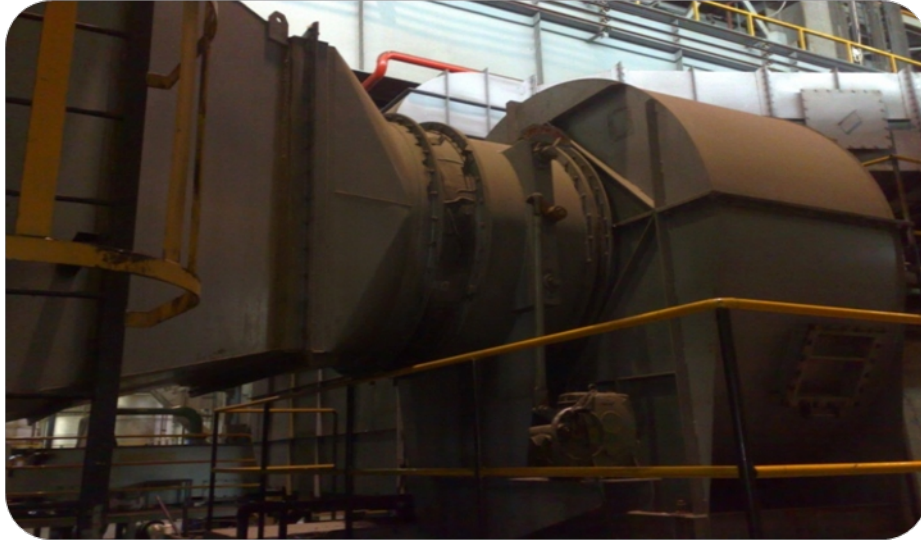
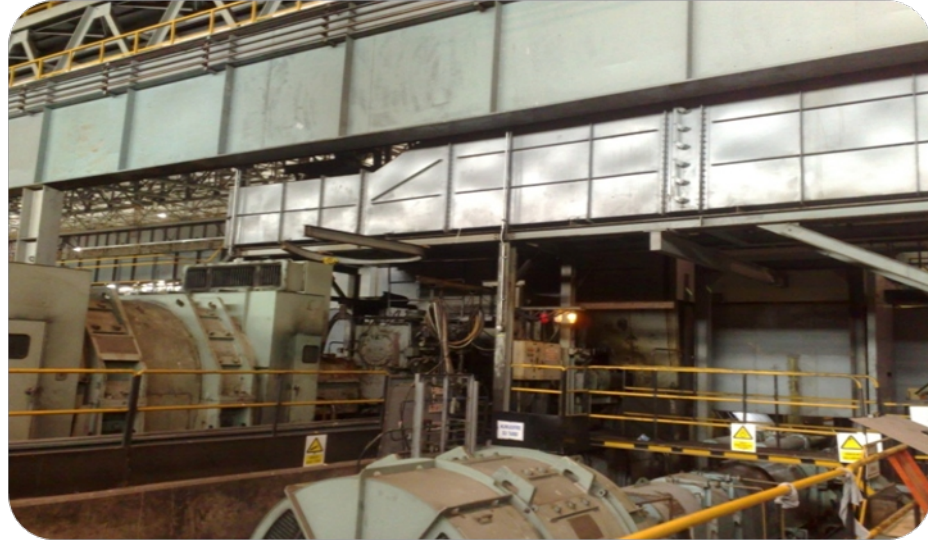
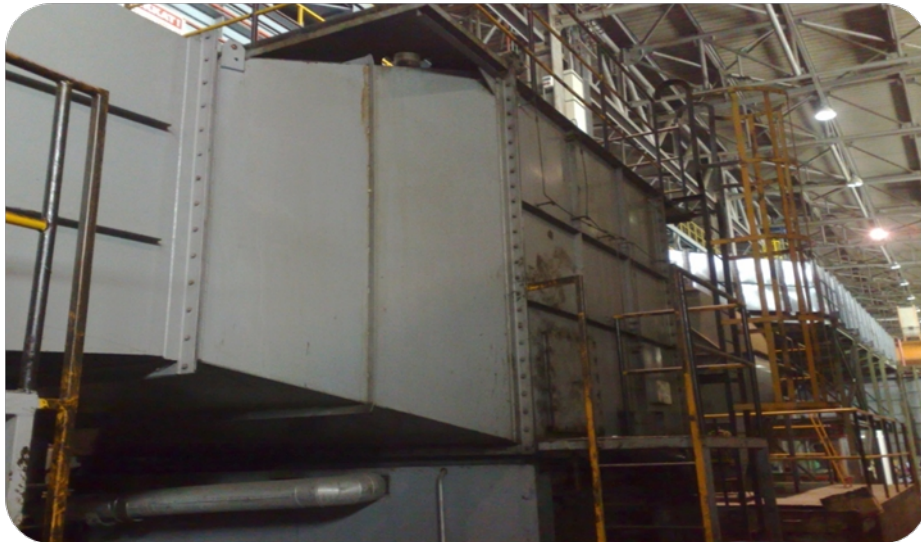
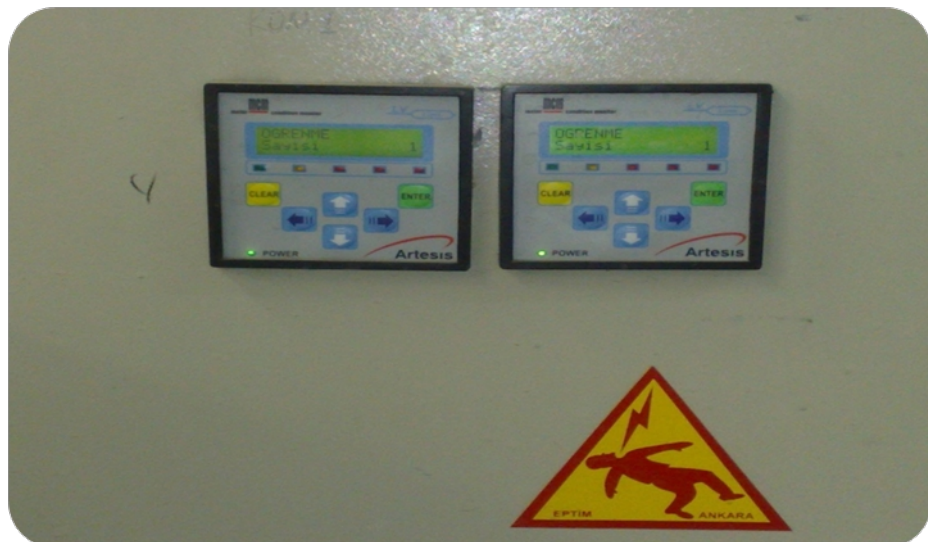
Dirty Filter

If the process load has not been altered deliberately, check for leakage, valve & vane adjustment, pressure gauge faults, manometer, dirty filters (fans, compressors). If the process is altered deliberately, MCM/PCM should be updated.

WATCH LOAD: If the process load has not been altered deliberately, check for leakage, valve & vane adjustment, pressure gauge faults, manometer, dirty filters (fans, compressors). If the process is altered deliberately, MCM/PCM should be updated.
